**Kissing Tree  
Villas  
*San Marcos , TX***

Report #: 40052-1  
Beginning: January 1, 2024  
Expires: December 31, 2024

**RESERVE STUDY  
Update "With-Site-Visit"**

May 3, 2024

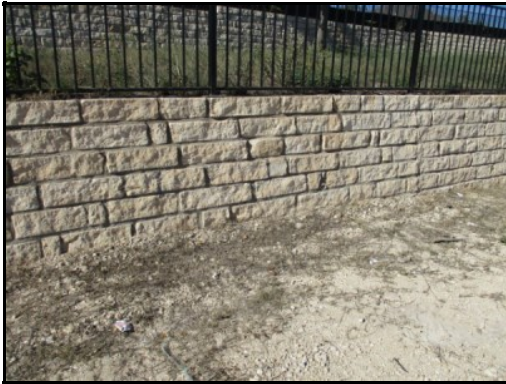
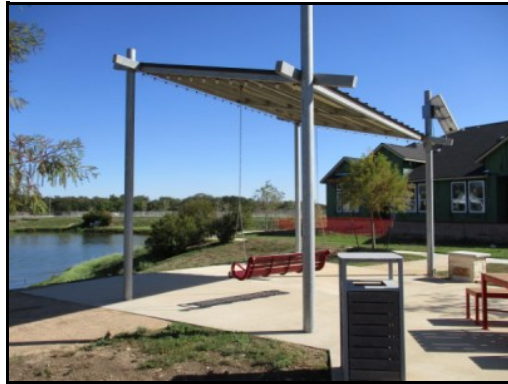
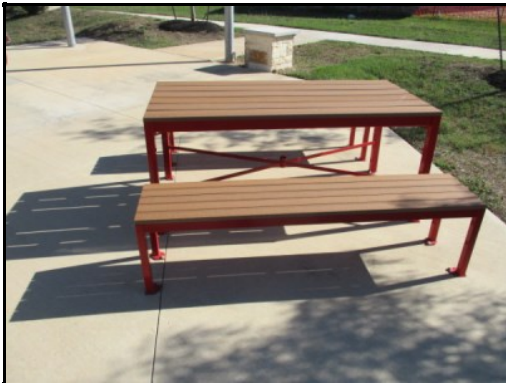
During our site visit on 10/17/2023, we started with a brief meeting with Matthew Dozier (General Manager) and Mark Weeden (Director of Asset Management), and then started the site inspection beginning with the streets. We visually inspected and were able to see all common areas. Please refer to the Component Details section at the bottom of the report for additional information on each of your Reserve components.

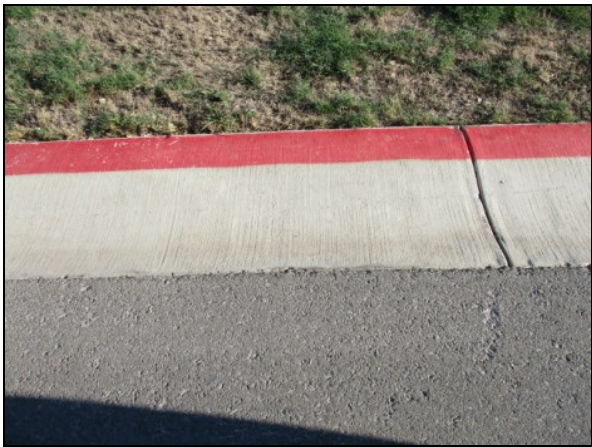
**Comp #: 212 Concrete: Curbs - Repair**

Comments: Funding provided to repair 5% or 362 LF of the total

Good condition: Concrete curbs and gutters determined to be in good condition typically exhibit even and smooth surfaces with normal wear. Minimal lifting and/or cracking evident at the time of inspection.

Under normal circumstances, concrete curbing should have a very long useful life (often assumed to be 50 years or more). Although difficult to predict timing, cost, and scope, we suggest a rotating “supplemental” allowance to fund periodic larger repairs that may be required over time. All maintenance, repair, and/or other related expenditures should be tracked and reported by the client during future reserve study updates. This component should then be re-evaluated based on most recent information and data available at that time.

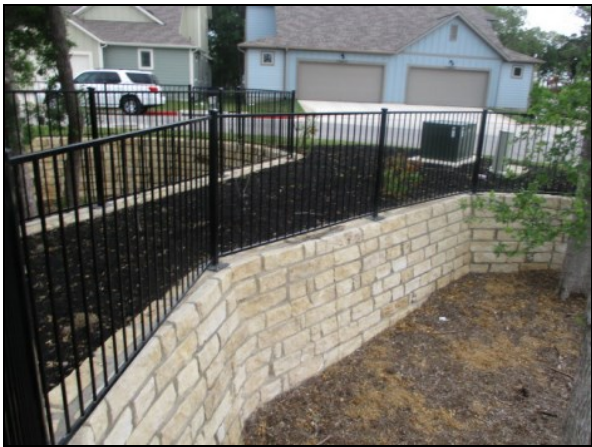
**Comp #: 503 Fencing: Metal - Replace**

Good condition: Metal fencing determined to be in good physical/structural condition is stable and upright, with no signs or reports of damage or required repairs. All components and hardware appear to be in serviceable condition with no unusual or advanced signs of wear or age. Fencing is in good aesthetic condition.

In our experience, metal fencing will typically eventually break down due to a combination of sun and weather exposure, which is sometimes exacerbated by other factors such as irrigation overspray, abuse and lack of preventive maintenance. For some types of fencing, complete replacement is advisable over recoating or refinishing due to relatively short lifespan of coatings and consideration of total life-cycle cost.

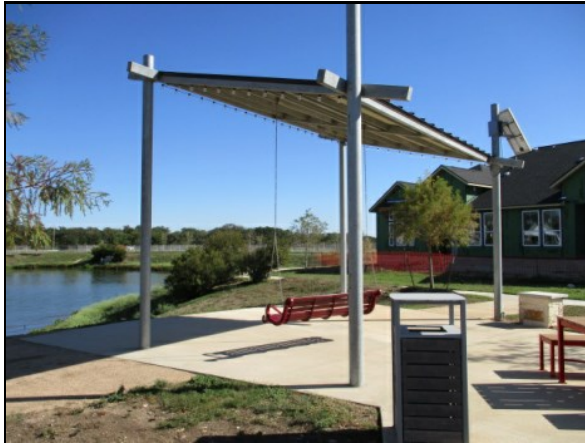
Comments: Good condition: Pavilions determined to be in good condition typically exhibit good, consistent finishes or coatings and all frame members and hardware appear to be strong and sturdy. Appearance is good and upholding aesthetic standards of the development.

As routine maintenance, inspect regularly and repair individual pieces or sections as needed from general operating funds. Clean and paint/stain along with other larger projects or as general maintenance to preserve the appearance of the structure and extend its useful life. If present, vegetation should be well-maintained and not allowed to become overgrown, which can eventually compromise the structure. Assuming ordinary care and maintenance, plan for major repairs or possibly complete replacement (if warranted) at roughly the interval indicated below.

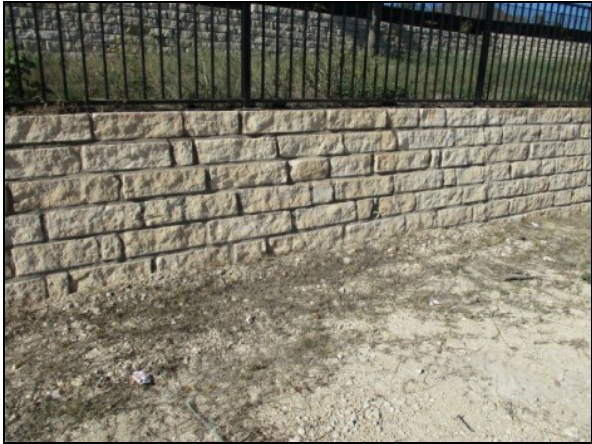
**Comp #: 517 Walls: Retaining - Inspect/Repair**

Good condition: Retaining walls determined to be in good condition exhibit straight alignment with no leaning/bulging sections. No reports of any unusual concerns or repair issues. Any exposed sections are properly painted or otherwise protected from the elements, and drainage appears to be sufficient.

Assumed to have been properly designed and installed with adequate base and surrounding drainage. Sections above ground should be inspected regularly and repaired as-needed from the operating budget. In our experience, retaining walls should have a very long useful life with minimal need for substantial repairs or maintenance. However, at longer intervals, major repairs and even complete replacement may be warranted. We recommend budgeting for such projects as shown below, but this component should be further evaluated by a qualified professional (i.e. engineer or technical professional) to determine proper scope of work and cost estimates. Unless otherwise noted, costs are based on replacement with comparable material/design.

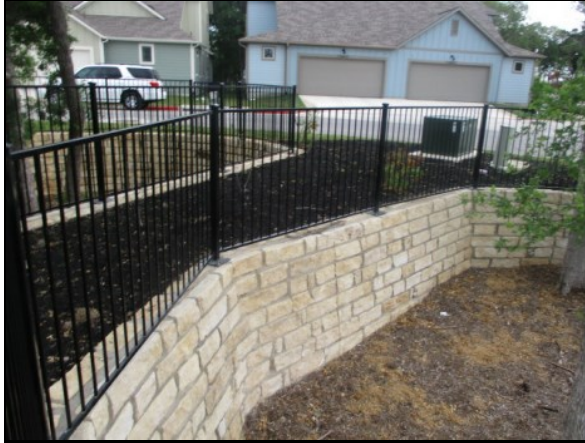
Comments: Good condition: Metal fencing determined to be in good condition typically exhibits a uniform coating or surface finish without any noticeable corrosion or rust. Color and appearance is consistent over most/all areas.

Painting not only protects the metal surface from excessive wear, but promotes a good, attractive appearance in the common areas. Metal fencing should be painted at the interval shown here in order to inhibit (or delay) onset of rust/corrosion, promote a strong aesthetic standard, and prevent/minimize costly repairs. Costs can vary greatly depending on existing conditions of fencing, which will dictate the amount of repair and prep work required. Thus, this component should be re-evaluated during future reserve study updates based on the most current conditions and information available at that time.
